The Owner's Guide to Piano Repair

Focus On: Replacement of Worn Asian-Design Hammer Butts and Flanges

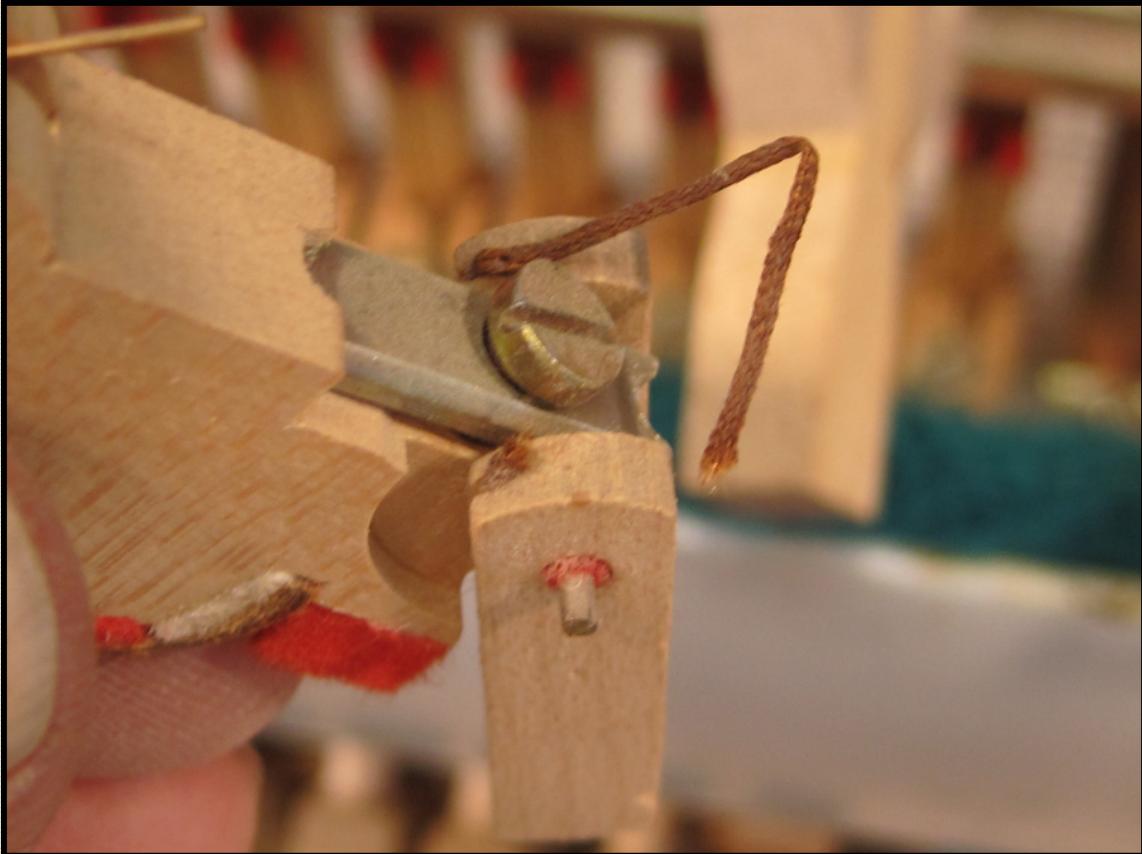
The Achilles heel of Yamaha, Kawai and other Asian-made pianos is a hammer butt assembly that relies upon a small braided cord to hold an essential spring in check. After years of use this cord is prone to breaking (as shown in photo on cover), which causes the piano action to perform unsatisfactorily.

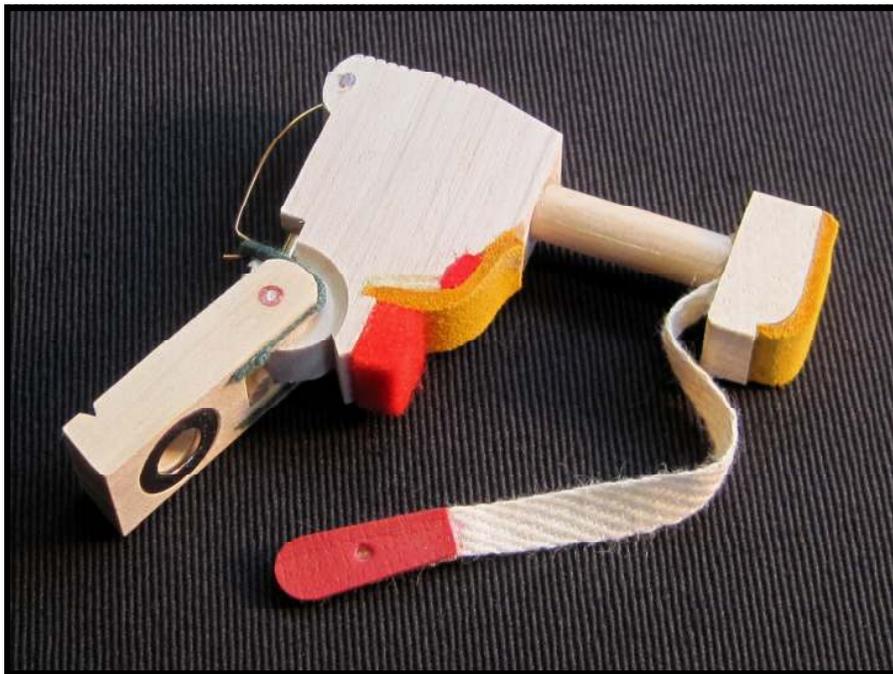
A new Asian-design hammer butt / flange assembly ready to install.

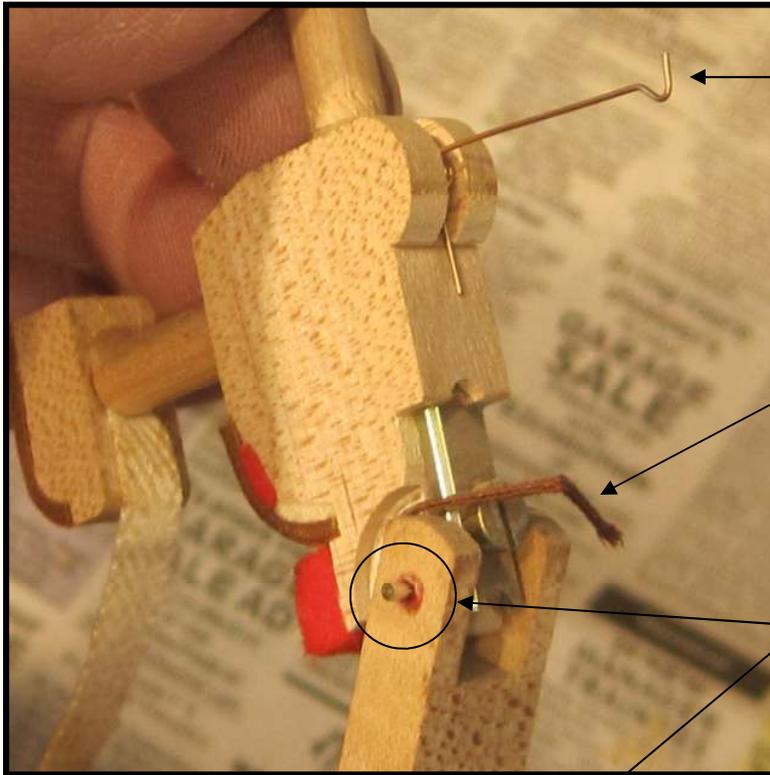
The following photos of used hammer butt / flange assemblies from a 1980s Yamaha studio upright illustrate the most common problem areas.

Hammer butt return spring: When held in check by the flange cord, this spring swiftly returns the hammer butt to its rest position so that it's ready to fire again the next time the note is played.

Flange cord: Although strong enough to hold the continuous tension of the return spring for decades, it eventually can give out and break.

Action center: The pivot point for the hammer butt. As the felt bushing and brass pin become worn, the fit of the pin loosens, causing sloppy play. The pins in the photos have worked loose entirely from one side of the flange, causing extreme wobble.

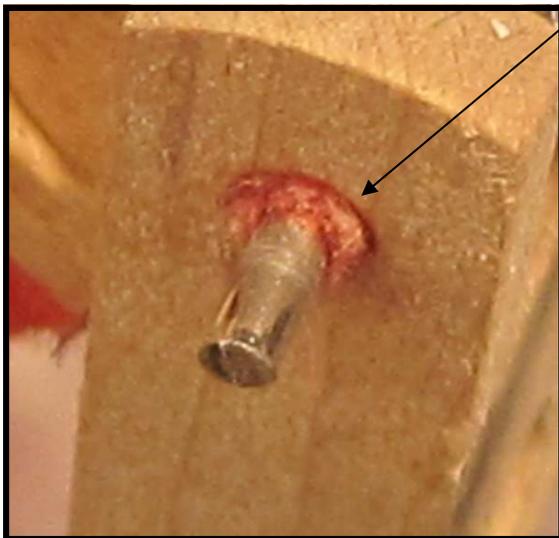
Although less obvious than broken flange cords, loose action centers also cause problems for the performance of the piano. Ordinarily, wear and tear of the felt bushing is the cause of overly loose action centers, but sometimes the brass pins themselves begin to wear away, as in the photo to the left. When an action center has thus loosened up, hammers wobble on their way up to the strings, striking less than a solid blow. In extreme cases, hammers may go off course to the point where they hit the wrong strings!

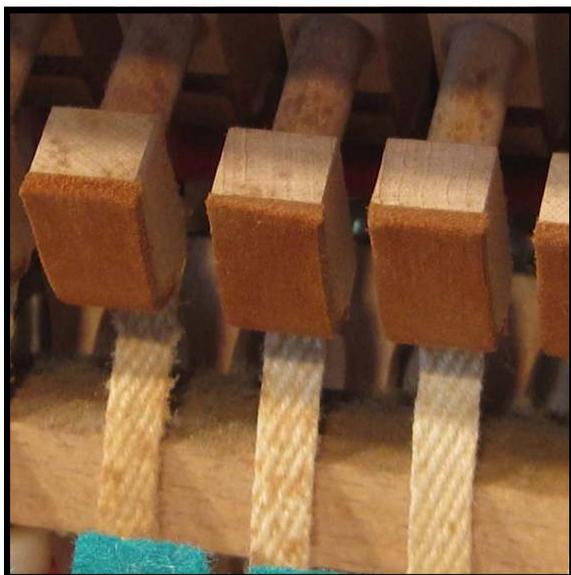
Old hammer butts

Consider the above photos showing a part called the catcher, which is faced with a buckskin (or similar) covering. When a note is played, this part is essential to preventing repeated strikes (called "bobbling" notes). The buckskin surface wears thin over the years, especially on portions of the keyboard which are played more heavily. In the photo on the left showing a set of original hammer butts, the buckskin covering the center catcher has worn thinner than the two adjoining catchers. The photo on the right shows the new catchers of replacement hammer butts. Not only is the buckskin covering uniform in thickness, providing a consistent cushion to the parts coming together, but it has a better ability to make a secure contact with the backchecks (the thick green felts at the bottom of the photo). The rougher texture of the new buckskin will grab the backchecks without slipping, as older, worn buckskin is prone to do.

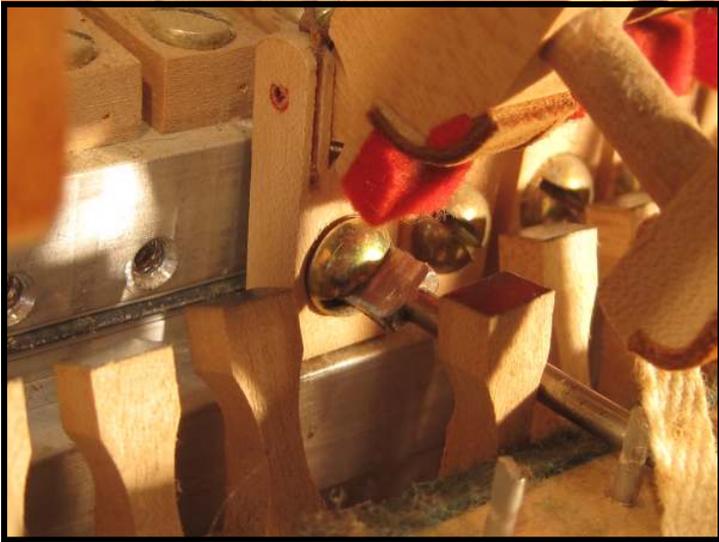
The first step is to remove the original hammer butt / flange assemblies from the piano action. These are taken from the action by carefully unhooking the bridle straps, then backing out the flange screws holding each assembly in place so that each unit may be lifted out.

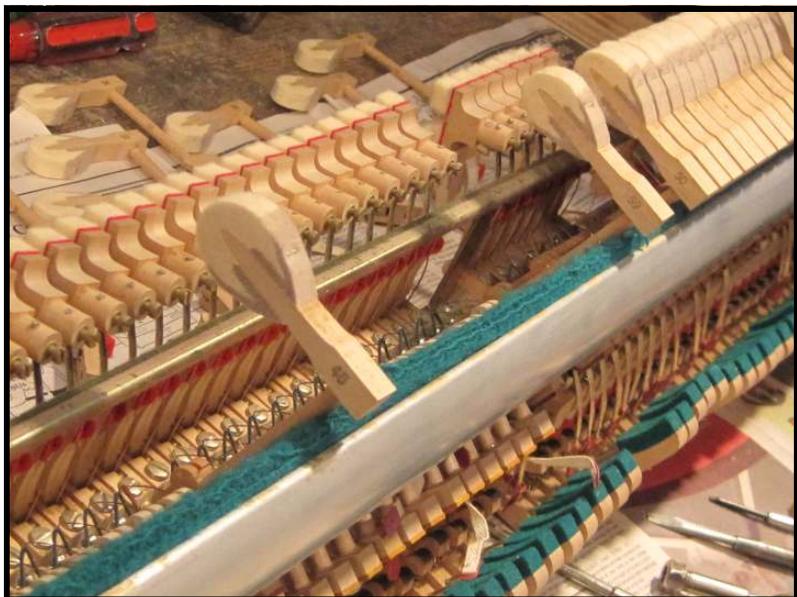
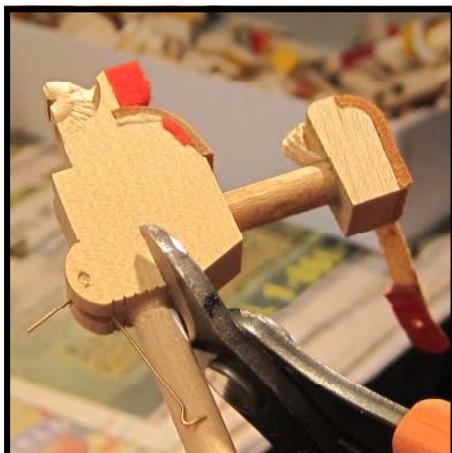
The old hammer butts are then removed from the hammer shanks, usually by using a pair cutters to cut along the grainline. Several cuts are required to remove the old part, at which time the shank needs to be cleaned of any remaining wood and glue.

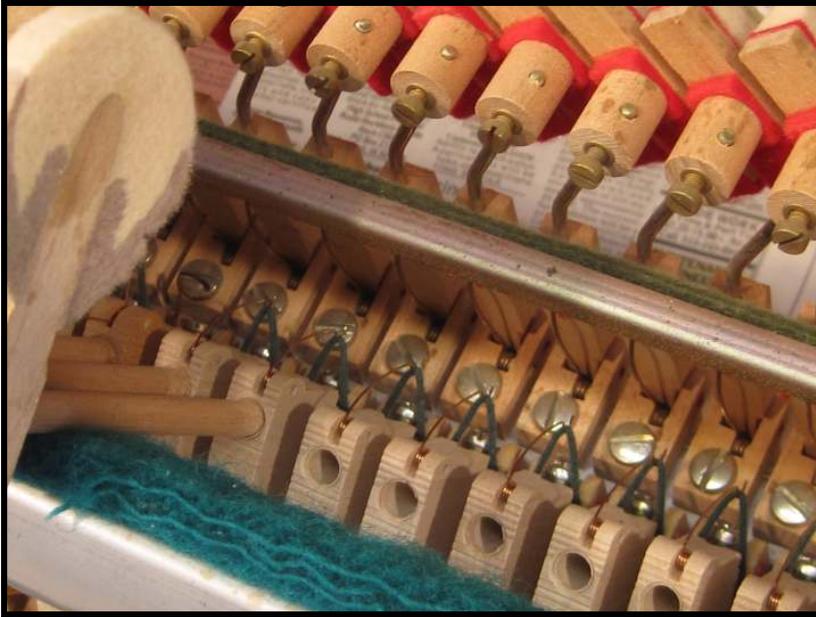
The hammer shanks are then dry fitted into the new hammer butt assemblies. With all the hammers in place, careful alignment will be done, and only then will the parts be glued together.

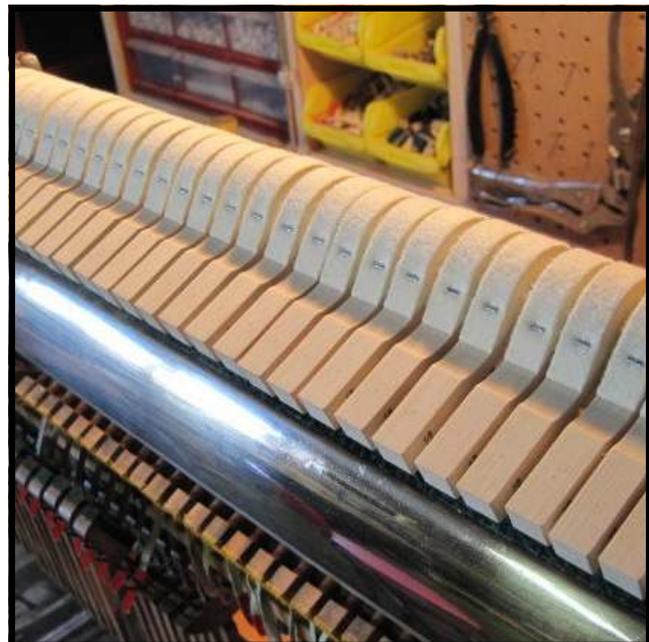
For the best results, worn hammers must be either shaped or replaced. Old hammers have often been badly cut into by the strings of the piano, resulting in them having an outer layer of felt which is dead or pulpy. By carefully removing the outermost layer of felt, hammers can be brought back to life. For badly worn hammers, replacement will give the piano a new lease on life. With either hammer reshaping or replacement, time will be needed to voice the hammers for consistent tone.

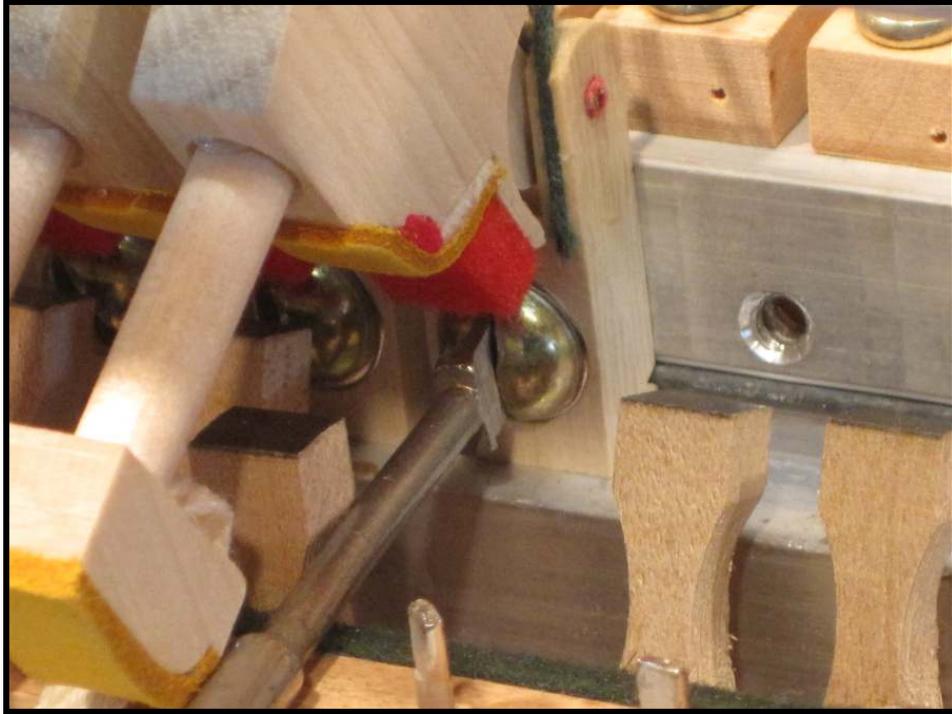
New hammer butt / flange assemblies being installed.
